## An Analysis of the Causes of Damage to Nata de Coco in the Fermentation Process

Moh Alfarizy<sup>1</sup>, Safinta Nurindra Rahmadhia<sup>1</sup>

<sup>1</sup>Food Technology Study Program, Faculty of Industrial Technology, Universitas Ahmad Dahlan, Indonesia

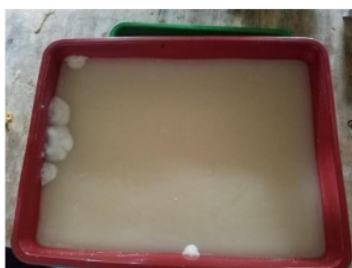
Figure 1 points out a damaged nata slab because of fungal contaminants, resulted by an unhygienic tray, facility, and infrastructure in the making of the media, leaving contaminants, such as dirt, sand, metal, and others. Tools used should be ensured for their hygiene to avert the transfer of contaminants, e.g., dirt, metal, sand, and so forth, which might cause damage or annoy the production process through contaminated tools (PPM dan PL, 2004).

Figure 1 Damage to Nata de Coco as a Result of Fungal Contaminant

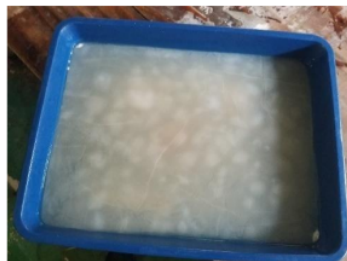
Figure 4 Nata Damage Owing to Incubation

Figure 4 showcases damage to a nata slab as a result of improper media incubation or storage, yielding a poor formation process of nata because of unprepared media for nata harvesting. Fermentation duration determined the formation process of nata (Wahono, 2016). The longer the fermentation period, the more hardened or chewier the nata texture. Within a proper range of periods, *Acetobacter xylinum* could convert glucose into cellulose fibers which were called nata. Moreover, a short fermentation period would likely create a rough nata texture by virtue of poor nata formation by *Acetobacter xylinum*.
